7.0 SRB POST FLIGHT/RETRIEVAL DEBRIS ASSESSMENT

The BI-101 Solid Rocket Boosters were inspected for debris damage and debris sources at CCAFS Hangar AF on 22 May 2000. Both boosters were in excellent condition.

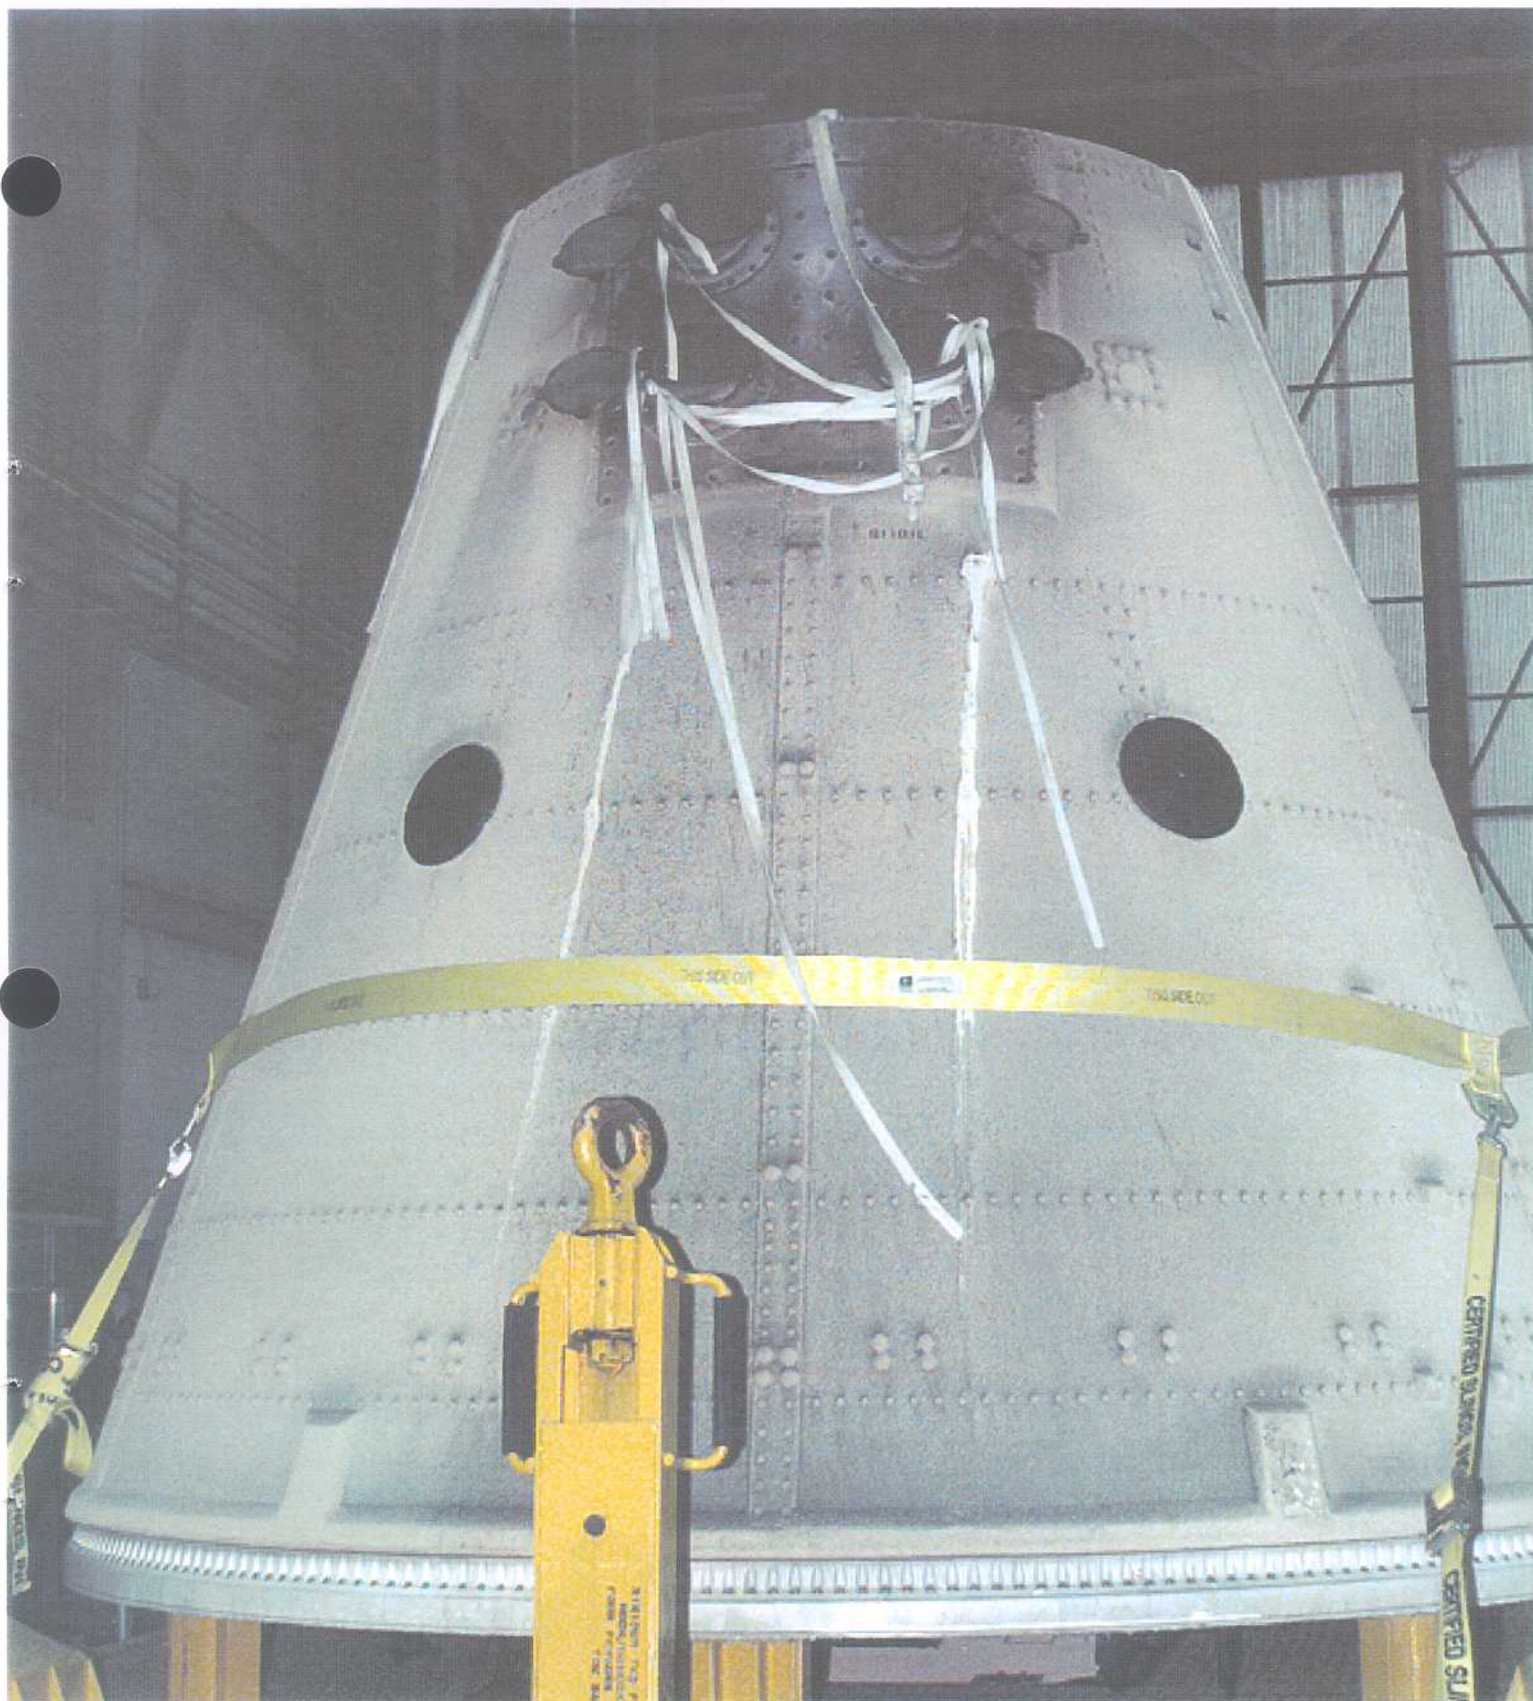
Photo 26: Frustum Post Flight Condition

The frustums exhibited no debonds/unbonds or missing TPS.

All eight BSM aero heat shield covers had locked in the fully opened position.

The frustums exhibited no debonds/unbonds or missing TPS. All eight BSM aero heat shield covers had locked in the fully opened position.

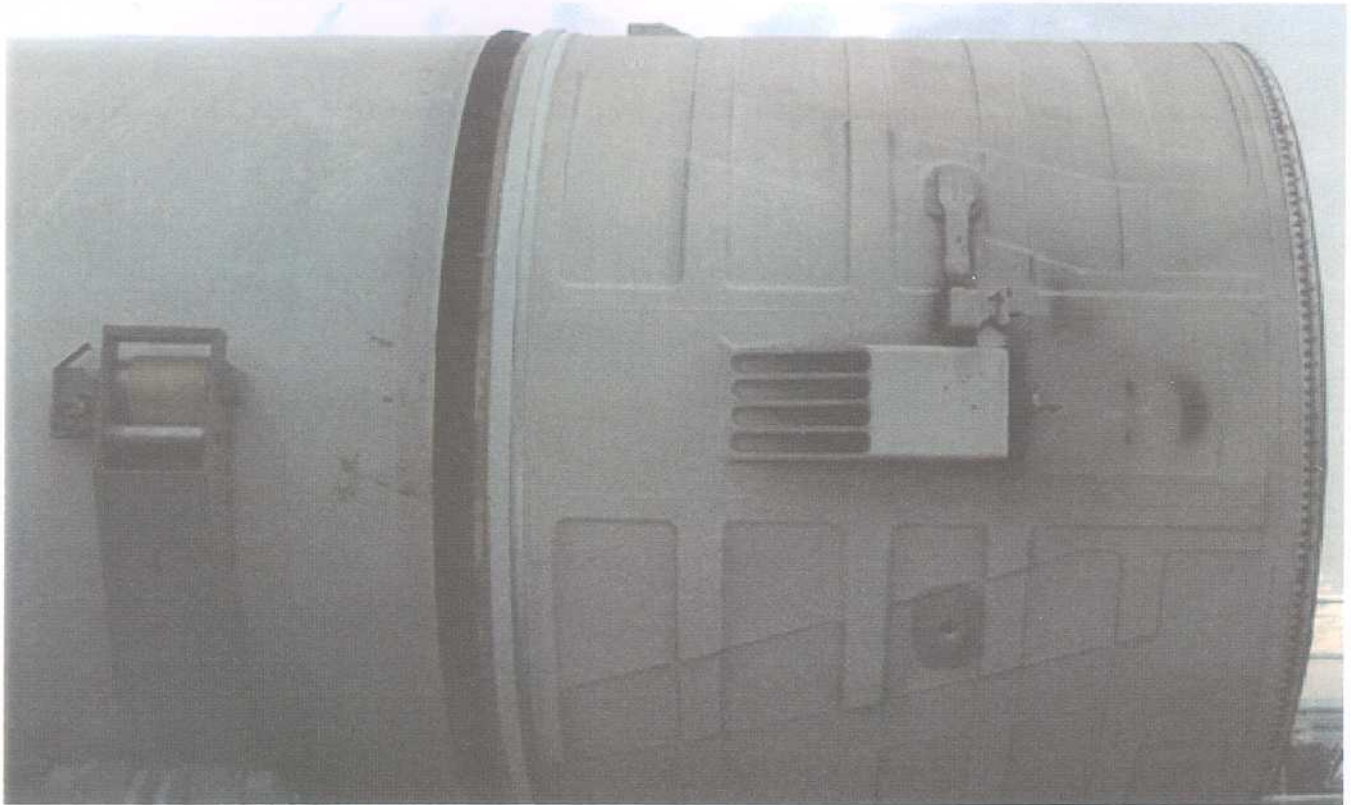
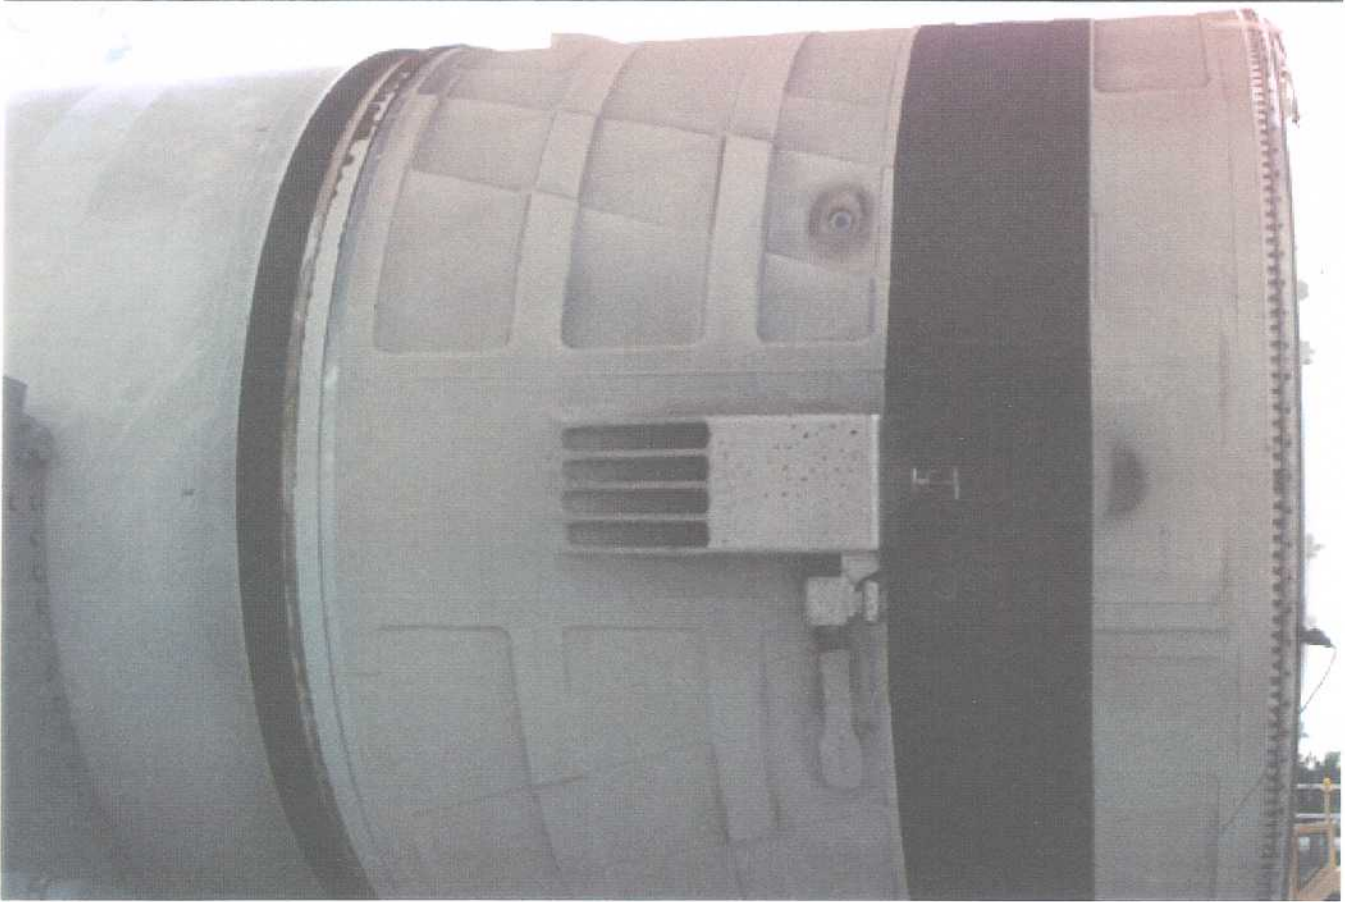
Photo 27: Forward Skirt Post Flight Condition

The forward skirts exhibited no debonds or missing TPS. RSS antennae covers/phenolic base plates were intact, though one layer of the RH SRB +Z base plate had delaminated.

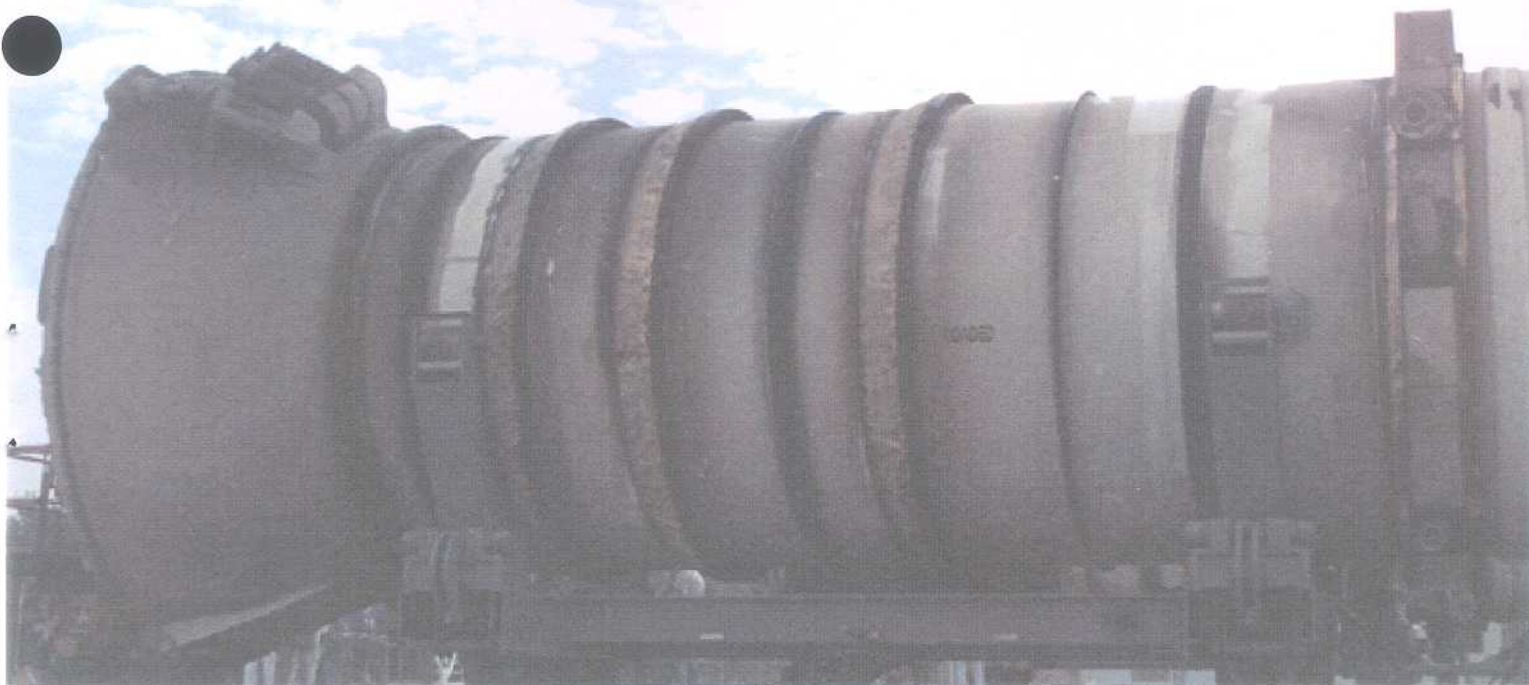
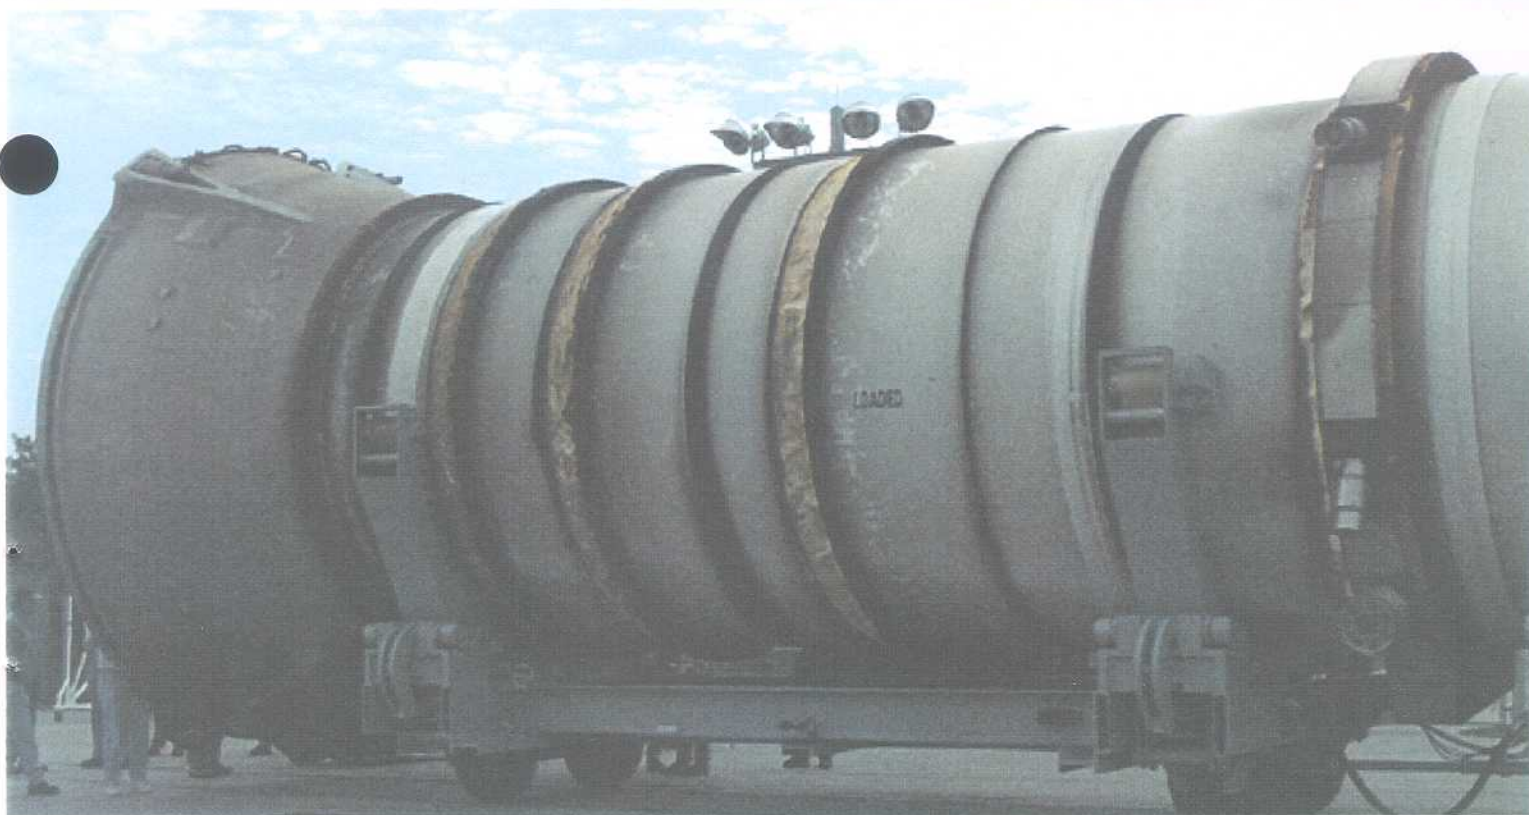
Aft skirt external surface TPS was nominal and in good condition. Typical blistering of Hypalon paint had occurred on the BTA insulation close-outs.

Photo 28: Aft Skirt Post Flight Condition
Aft skirt external surface TPS was in good condition
